No. 1235

AN INVESTIGATION OF A THERMAL ICE-PREVENTION SYSTEM FOR A
CARGO AIRPLANE. VIII - METALLURGICAL EXAMINATION OF THE
WING LEADING-EDGE STRUCTURE AFTER 225 HOURS OF FLIGHT
OPERATION OF THE THERMAL SYSTEM

By Maxwell Harris and Bernard A. Schlaff

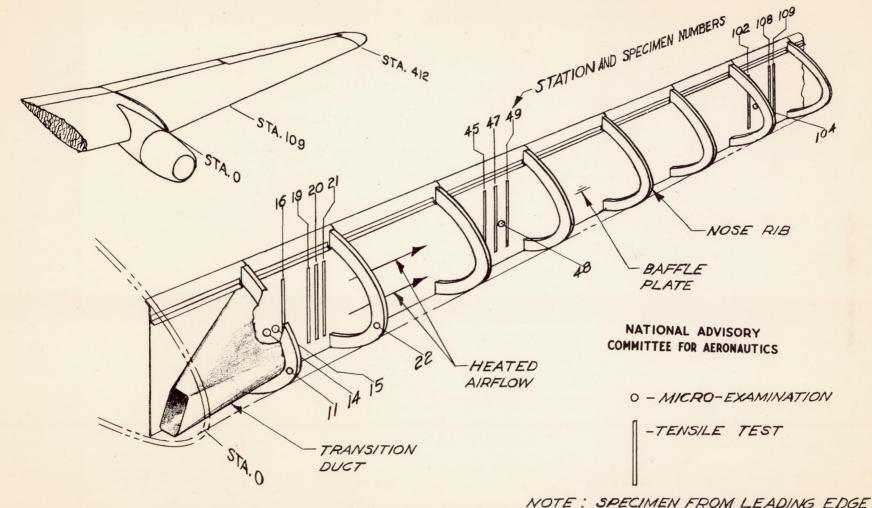
OUTER SKIN TAKEN AT STATION
II NOT SHOWN.

FIGURE 2.- LEADING EDGE OF THE LEFT WING OUTER PANEL SHOWING LOCATION OF SPECIMENS
TAKEN FOR MICRO-EXAMINATION AND TENSILE TESTS, C-46 AIRPLANE.

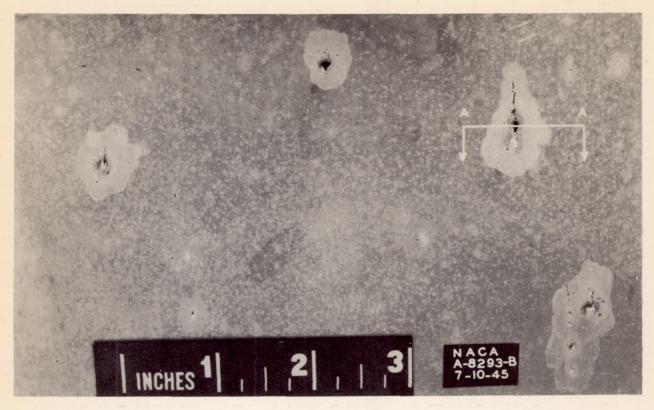
Visual examination of the baffle plate revealed a light deposit of soil accompanied by an appearance of slight pin-point corrosion as shown in figure 3. After removal of the soil, the positive presence of corrosion was established and is shown in figure 4. large black lumps adhering to the sheet (seen in fig. 3) were identified as particles from a synthetic sponge-rubber gasket which was located at the inboard end of the transition duct (station O. fig. 2). The heat had disintegrated a portion of the gasket and the hot air had carried the particles into the ducting where they had deposited and hardened on the surface of the baffle plate. Beneath these black lumps of synthetic rubber a severe corrosion was noted. Examination of a cross section of the baffle plate, indicated by the line A-A on figure 3, revealed a marked pitting of the cladding, but a normal core (fig. 5). Microexamination of a cross section beneath another particle at station 14 showed a definite attack of the core along the grain boundaries (fig. 6). The fact that the synthetic rubber particles set up intercrystalline corrosion at station 14 and not at station 59 may be attributed to the probably higher baffle-plate temperature at station 14 and thus a greater susceptibility to intercrystalline corrosion at that station.

Figure 3.- Corrosion and soil deposit on baffle plate between stations 56 and 60. The large black spots are particles from a synthetic sponge-rubber gasket.

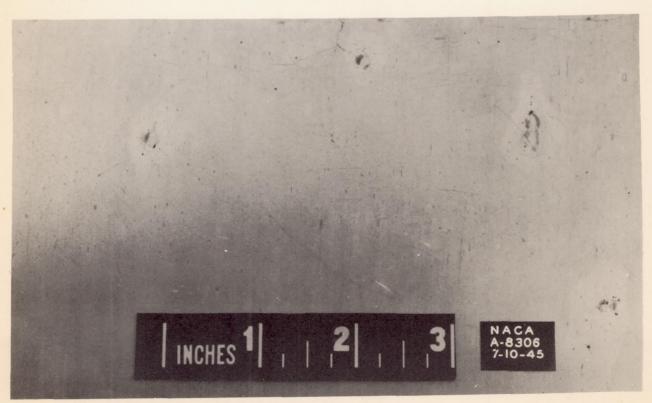
Figure 4.- Area of baffle plate shown in figure 3 after cleaning with acetone.

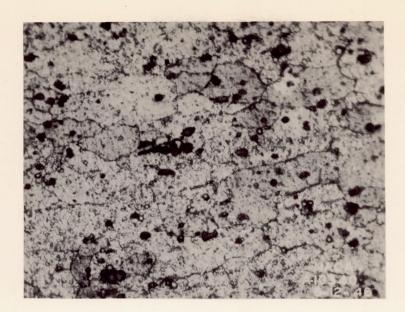
A further examination of the cross section of the baffle plate at station 14 revealed a decidedly aged core structure (fig. 7). There is a heavy precipitation at the grain boundaries and within the grains. Long periods of heating have begun a coalescence of the precipitation resulting in relatively large rounded particles. There is also a considerable decrease in grain contrast. Aluminum alloys exhibiting such a structure are reported in reference 12 to be quite susceptible to intercrystalline corrosion.

A section examination of the baffle plate at station 15 showed a structure identical to that of figure 7, while examination of baffle-plate sections at stations 48 and 104 showed structures similar to figures 9 and 10. This indicates that the overheating of the baffle plate and attendant reduction in resistance to corrosion did not extend to station 48.

Figure 7.- Section showing core structure of baffle plate at station 14. Magnification, 500X; double-etched with hot 25-percent solution of nitric acid and Keller's etch. Precipitation is evident at and within the grain boundaries.

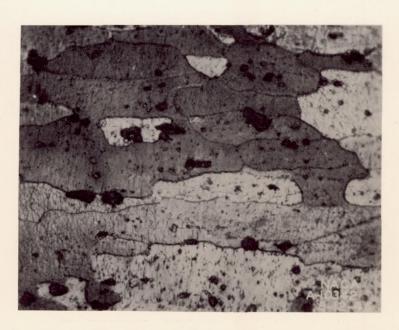
Microexamination of the section of the web of the nose rib at station 11 shows minute amounts of precipitation at the grain boundaries (fig. 8), but it is not believed that any excessive temperature effects are indicated. References 1, 3, and 14 report that Alclad 24S-T may be aged artificially without detrimental effect, provided the correct combination of temperature and time at the elevated temperature is maintained.

Figure 8.- Section showing core structure of nose-rib web at station 11. Magnification, 500X; double-etched with hot 25-percent solution of nitric acid and Keller's etch.

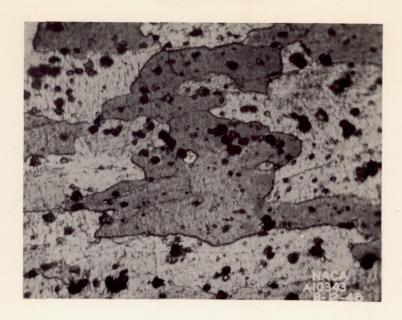
Figures 9 and 10 show the structures of the leading-edge outer-skin station 11 and in the web of the nose rib station 22. These microstructures are comparable to that of normal 24S-T as reported in reference 11. The highest temperature recorded at the nose rib station 22 was 256° F (reference 7) but no temperature data are available for the area of the nose skin at station 11.

Figure 9.- Section showing core structure of leading-edge outer skin at station 11. Magnification, 500X; double-etched with hot 25-percent solution of nitric acid and Keller's etch.

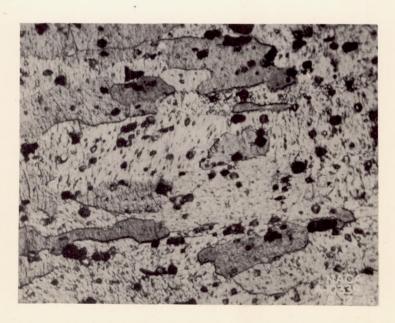
Figure 10.- Section showing core structure of nose-rib web at station 22. Magnification, 500X; double-etched with hot 25-percent solution of nitric acid with Keller's etch.

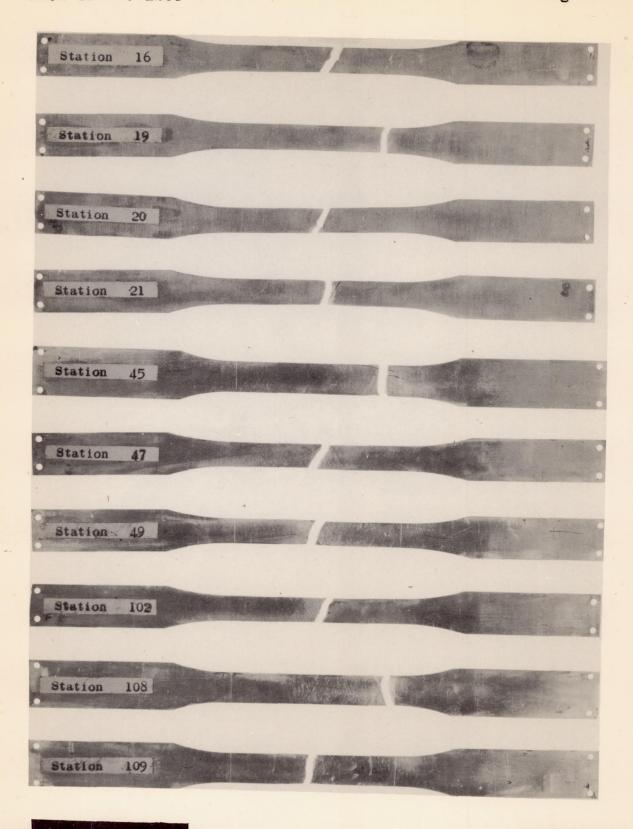
Figure 11.- Alclad 24S-T tensile specimens, taken from the baffle plate of the C-46 airplane wing thermal system, after fracture.

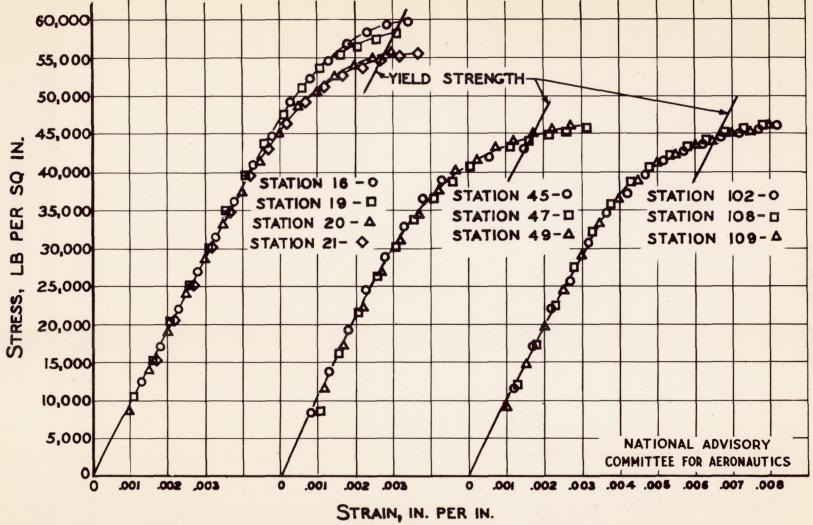
It may be noted in table I that from station 16 to 21, a distance of only 5 inches, there is a continuous decrease in yield strength and an attendant gain in elongation, approaching room-temperature values. This indicates an effective differential in temperature, even over this short distance, substantiating investigations (reference 3) on the artificial aging of Alclad 24S-T which have revealed that in a critical temperature range of from 300° F to 375° F small differences in temperature may cause quite noticeable changes in yield strength. The values obtained for the ultimate tensile strength and yield strength for the specimens from stations 45, 47, 49, 102, 108, and 109 do not indicate any marked temperature—aging effect as they compare closely with the figures given in reference 15. The stress—strain curve for each specimen is shown in figure 12. This figure shows clearly the

increased ultimate and yield strengths of the specimens from stations 16 to 21 resulting from artificial aging. The yield at 0.2-percent offset is indicated by the short intercept line at the knee of each curve. Essentially, the modulus of elasticity is the same for all curves, which is normal for room-temperature tensile tests of this material.

FIGURE 12- STRESS-STRAIN CURVES FOR ALCLAD 24S-T ALUMINUM ALLOY TEST SPECIMENS TAKEN FROM THE BAFFLE PLATE OF A THERMAL ICE-PREVENTION SYSTEM INSTALLED IN A C-46 AIRPLANE WING.
